**Site Inspection Report  
Clovis Air Force Base  
Precision Bombing Range No. 1  
Lea County, New Mexico**

*FUDS Project No. K06NM037400  
March 2007*

*In Support of*  
**FUDS MMRP Site Inspections Project**

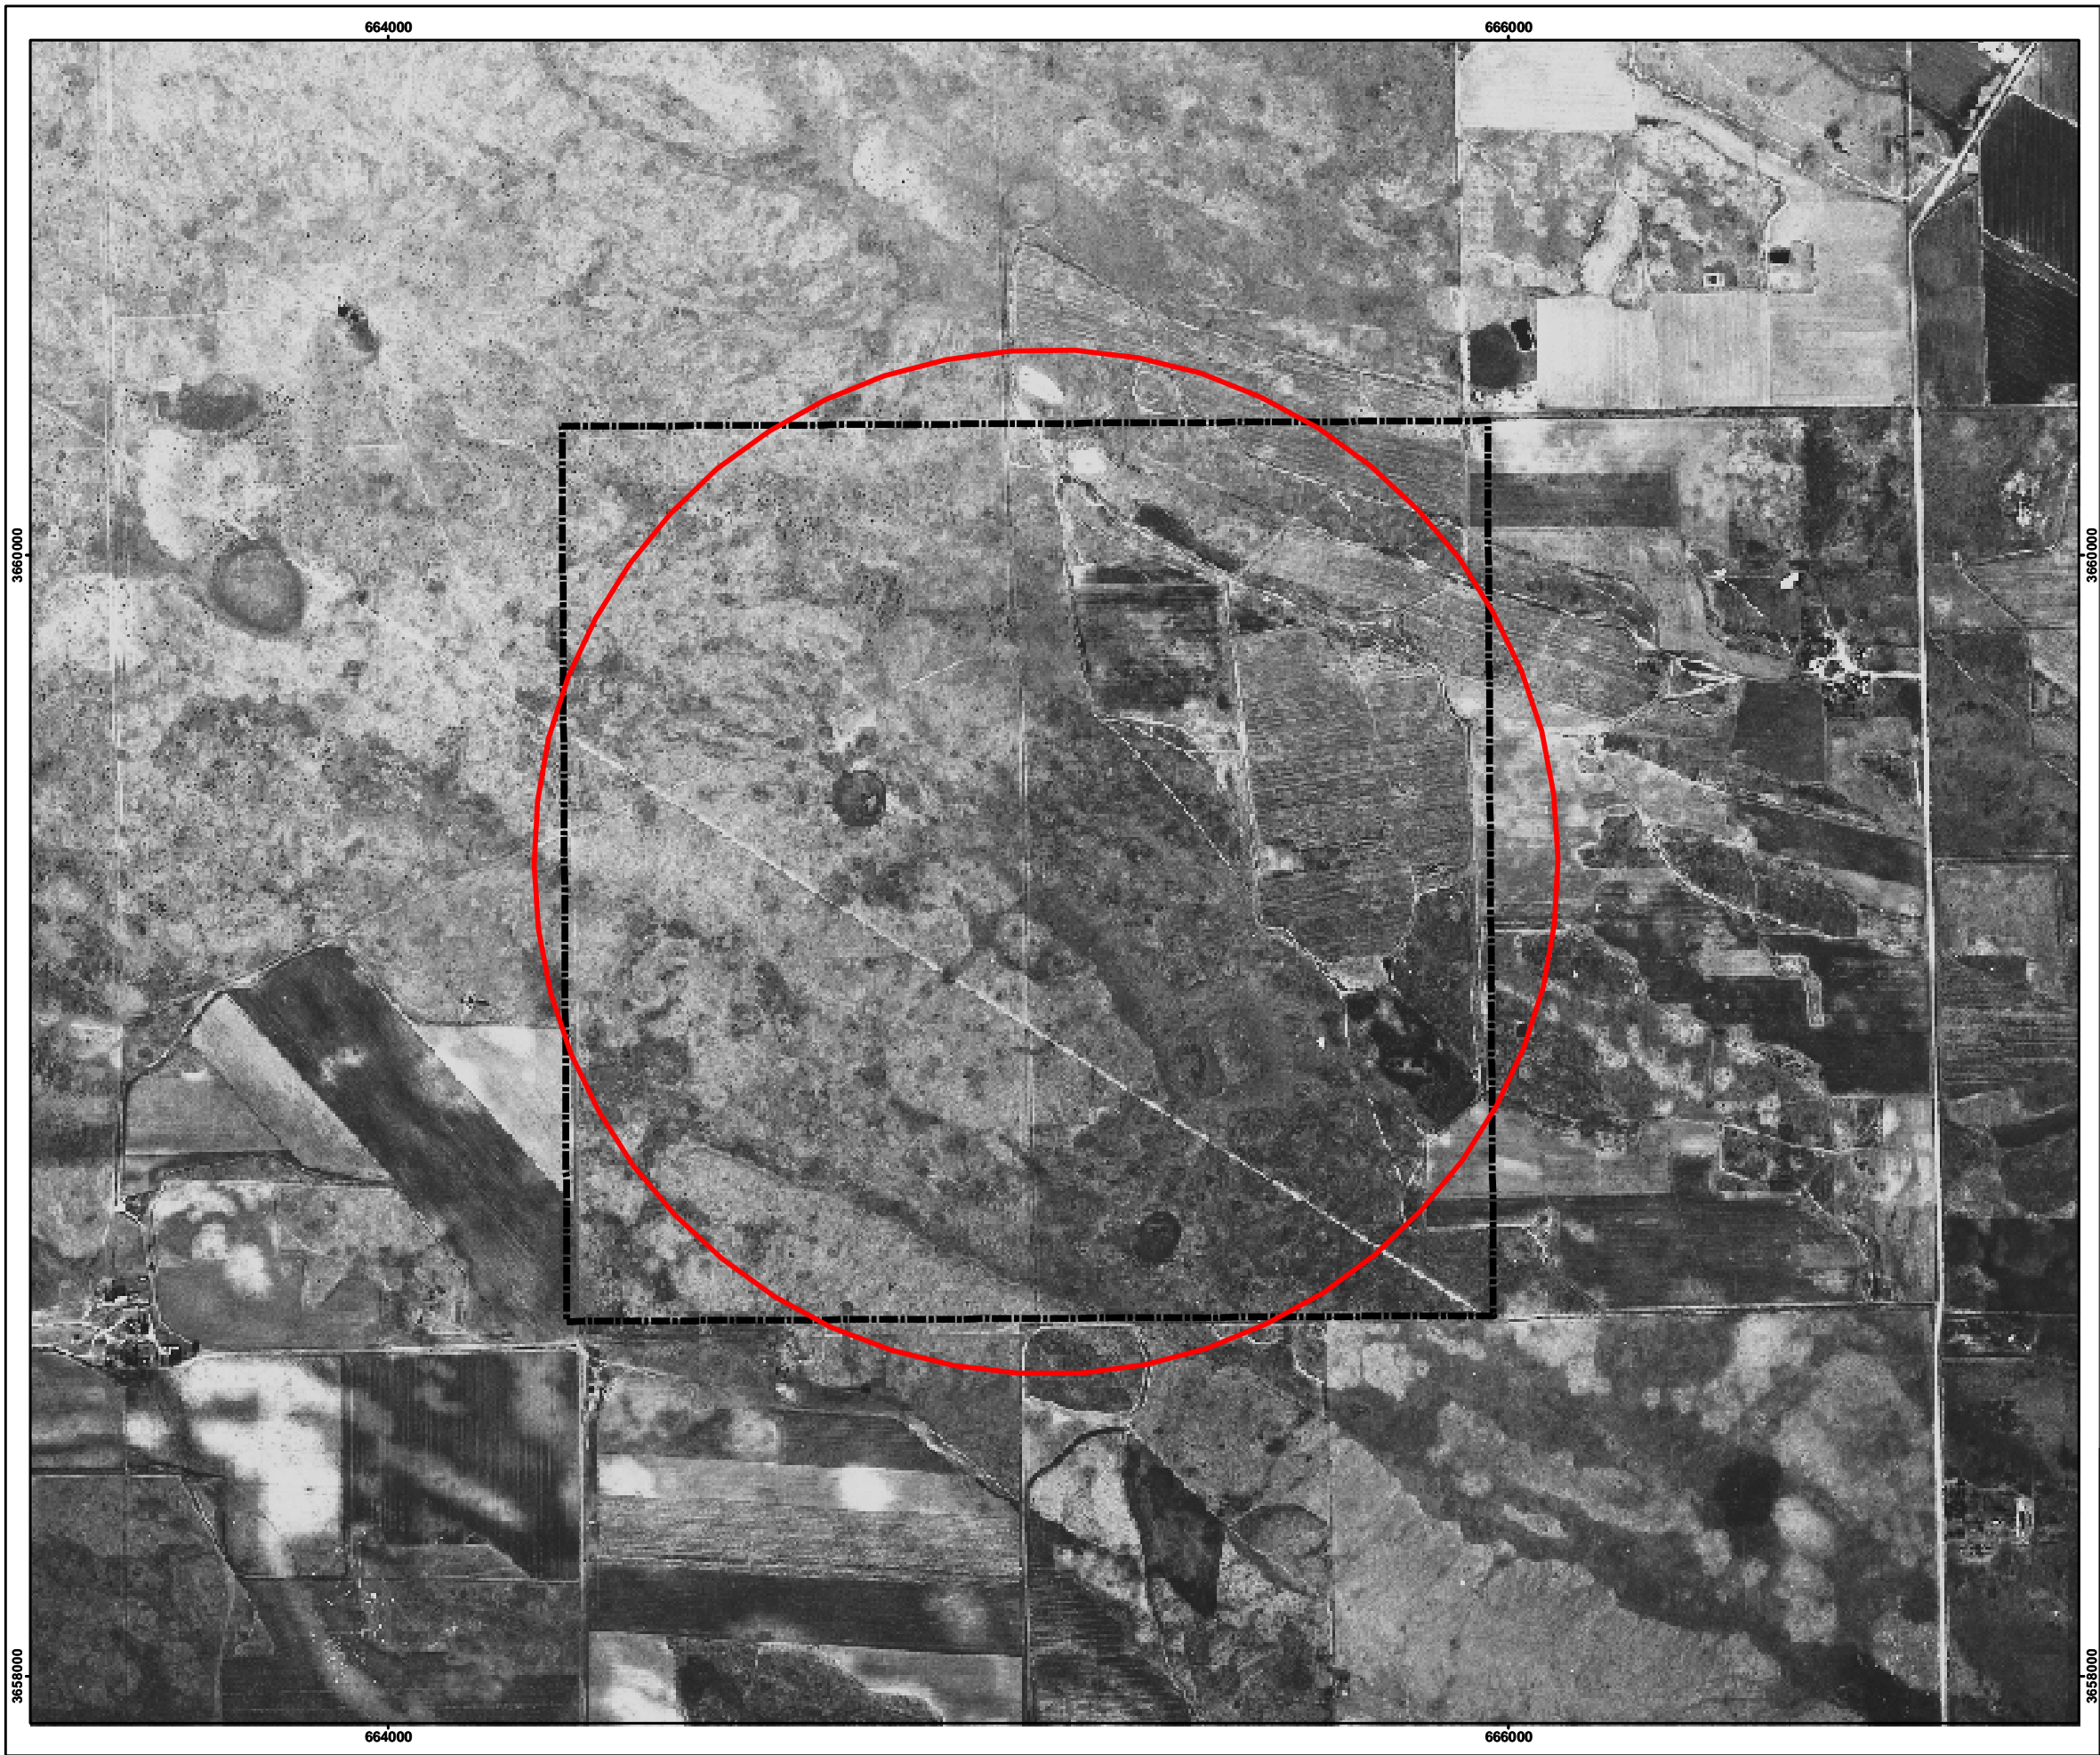
Figure 2.3

Information observed in an aerial photograph of the site from 1996 and provided in the PA and ASR supplement indicate that the Clovis AFB PBR No. 1 site was never used for the intended purpose. There have been no known observances of MEC at this site.

1966 Historical Aerial Photo  
Clovis PBR #1  
FUDS Project # K06NM037400  
Lea County, New Mexico

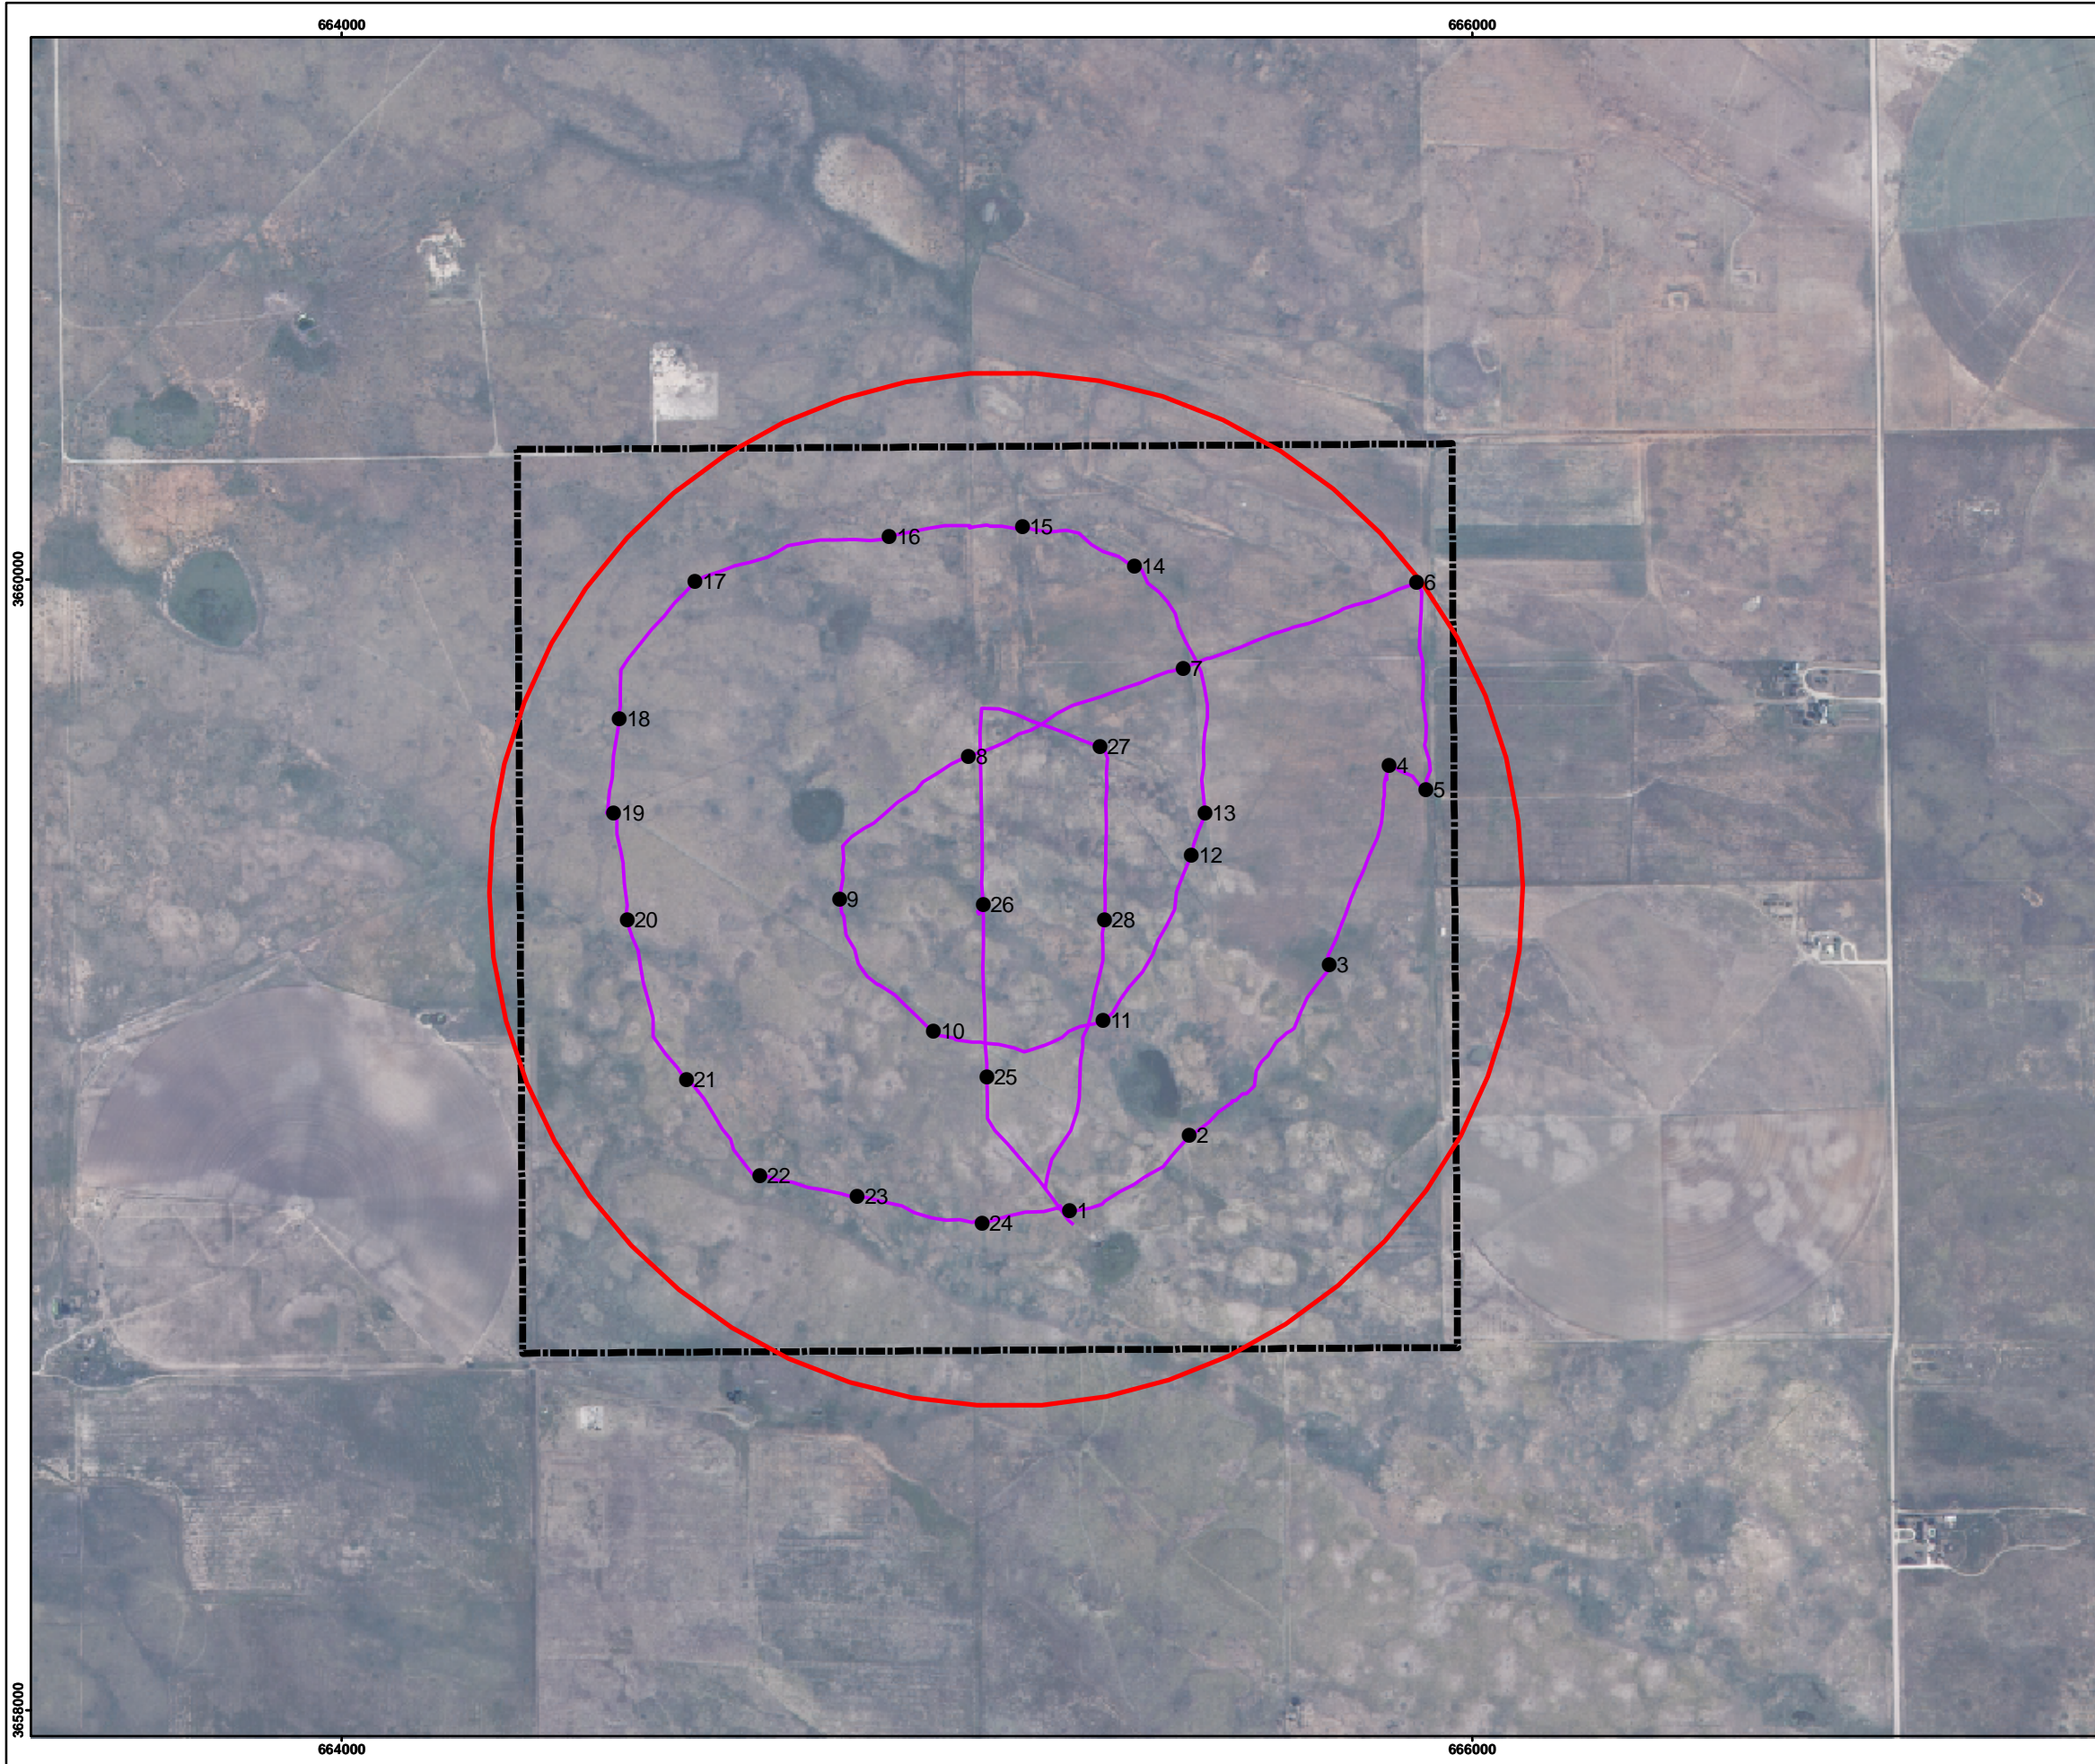
Figure 4.1

4.1.1.4 During the QR, the SI team noted 28 discrete field observations such as topography, soil color, drainage, and the presence of any barriers. No observation of MEC, munitions debris, small arms debris, or subsurface anomalies occurred during the QR. Related field forms are provided in Appendix D, and a photodocumentation log of the QR is provided in Appendix E.

**Qualitative Reconnaissance and  
Field Observation Locations**
